Liner Plate Rehabilitates Tunnel, Allows Park Trail to Remain Open

Jonathan Run - Ohiopyle State Park

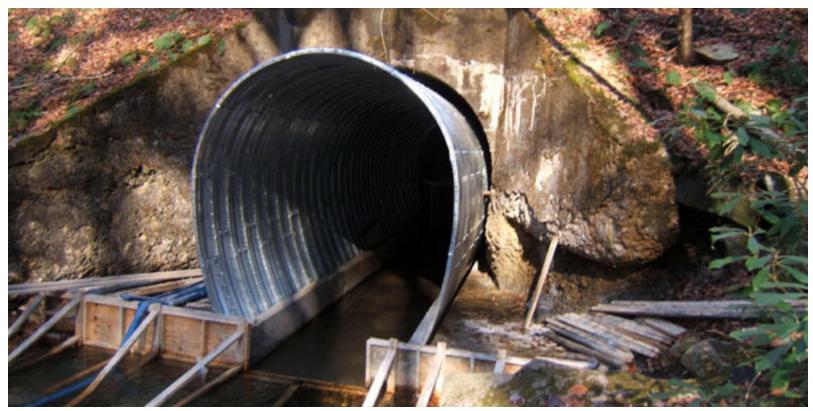
Due to the 80' of fill over the existing structure, accessibility to the culvert was difficult. A 5 gage, 2-flange galvanized steel 11' x 11'-7.5" Tunnel Liner Plate in a horseshoe arch shape was chosen for its cost effectiveness and ability to be delivered to the remote site. During the construction phase, the Tunnel Liner Plate was delivered to the jobsite as unassembled curved plates. These plates were then bolted together and installed, plate by plate, as the tunnel advanced.

WG Land Company, LLC of Champion, Pennsylvania, installed 219' of Tunnel Liner Plate. The structure was approximately 11' in diameter and provided enough waterway area to accommodate the drainage capacity for Jonathan Run during flood events.
